**Inspection Report**  
**Minerals Regulatory Program**  
Report Date: December 20, 2006

**Mine Name:** Reef  
**Operator Name:** Castle Valley Stone

**Permit number:** S0150094  
**Inspection Date:** December 15, 2006  
**Time:** 10:50-11:10 AM

S0150094, Reef Mine, Castle Valley Stone

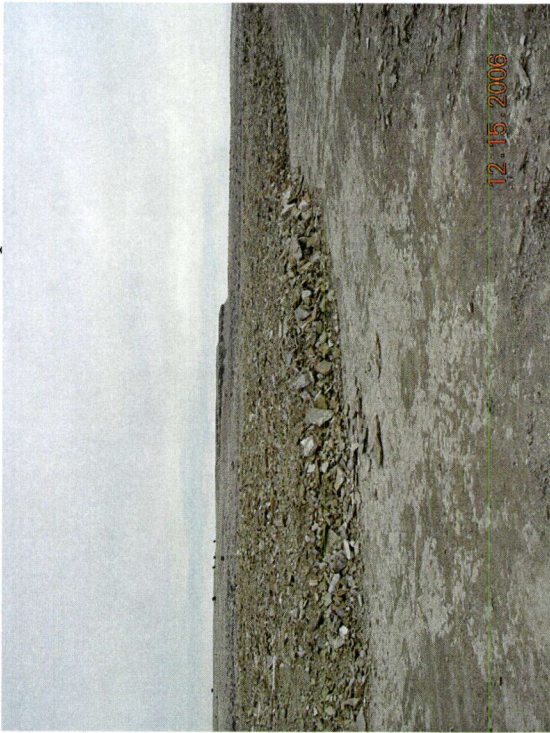
The site has been basically regraded, but there is a little more work that should be done to complete the job. Surrounding areas are flat, but the mine site was left with small rises or banks (Photos 1, 2, and 3). These are not significant but could be smoothed.

Photo 1. The site has been basically graded, but I felt the transition between the waste and the areas with little waste could be smoothed out.

If this site is being permanently closed, the operator should remove the stone, complete the grading, and seed (if seeding has not already been done). If the site is not being permanently closed, the operator should still apply an interim seed mix.

The Division needs to retain enough money in the surety to remove the pallets of stone, complete some minor grading, and for revegetation. Revegetation includes breaking up the surface by ripping or gouging. The cost for additional grading could probably be included in the cost for ripping.

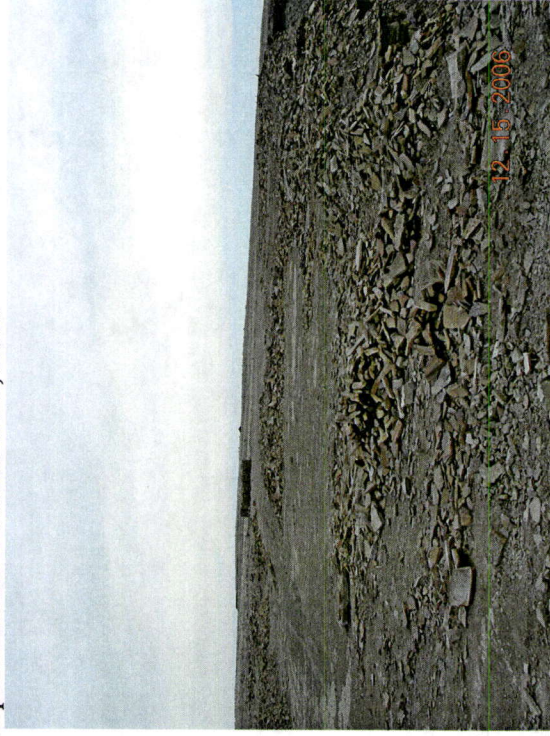
Photo 2. Here, again, I felt the waste could be better smoothed out.

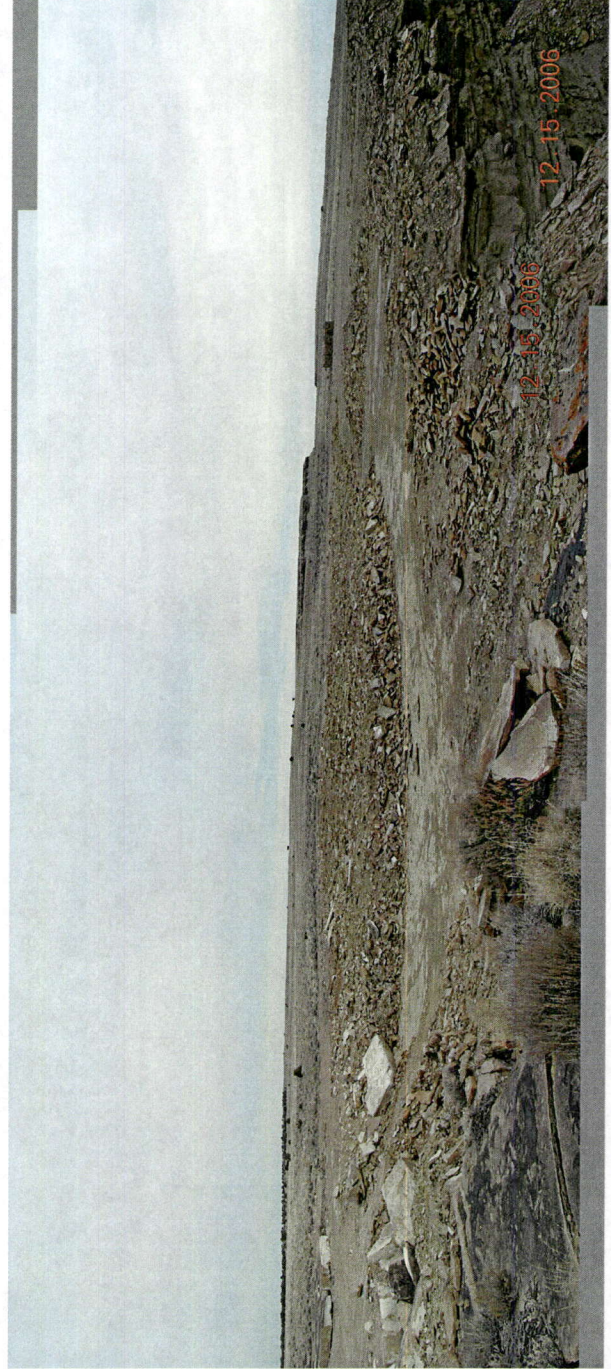
Photo 3. Panorama of the mine site.

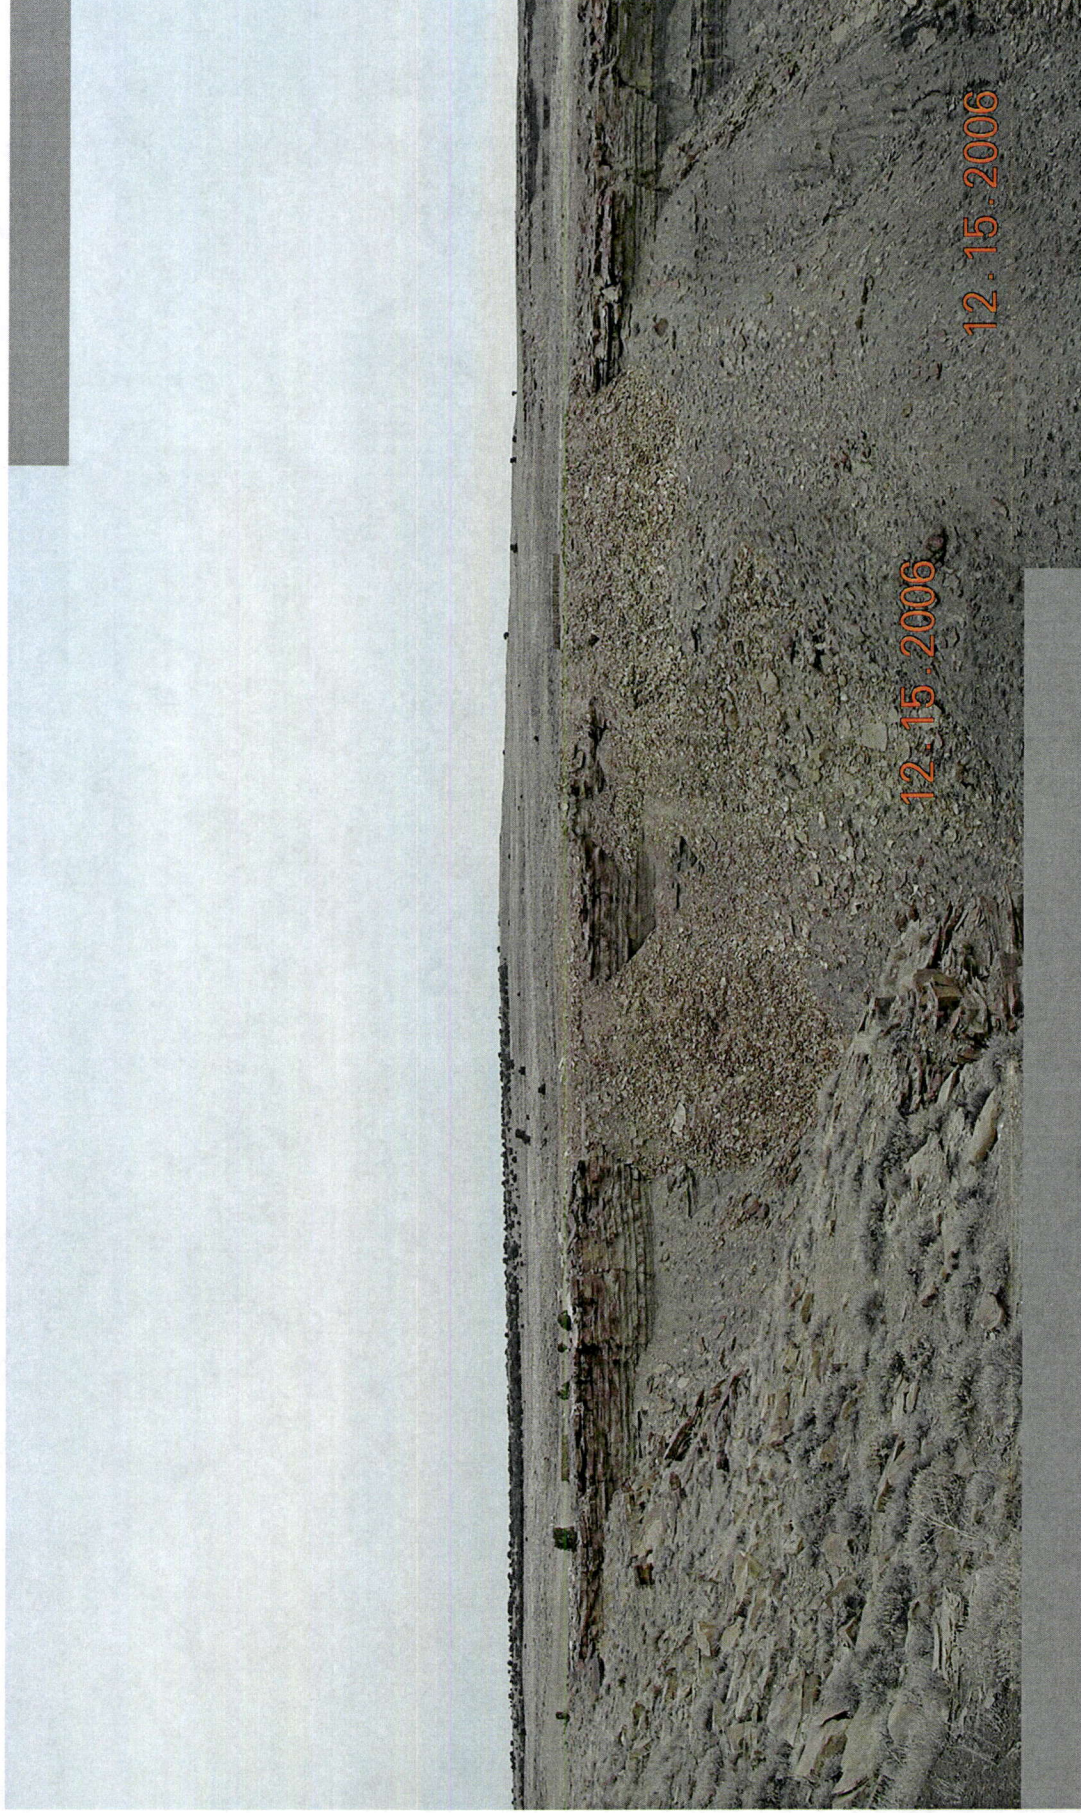
As can be seen in Photo 4, some waste was pushed over the edge of the cliff.

Photo 4. Panorama showing how waste material was pushed over the edge of the cliff.

At this point, there is not much that can be done about the waste that was pushed over the hill. Any attempt to retrieve the material would only be partly successful, and it would create a lot of additional disturbance and erosion potential.
